REPORT NO. 3539

THE BALTIMORE AND OHIO RAILROAD COMPANY

IN RE ACCIDENT

AT CASNER, ILL., ON

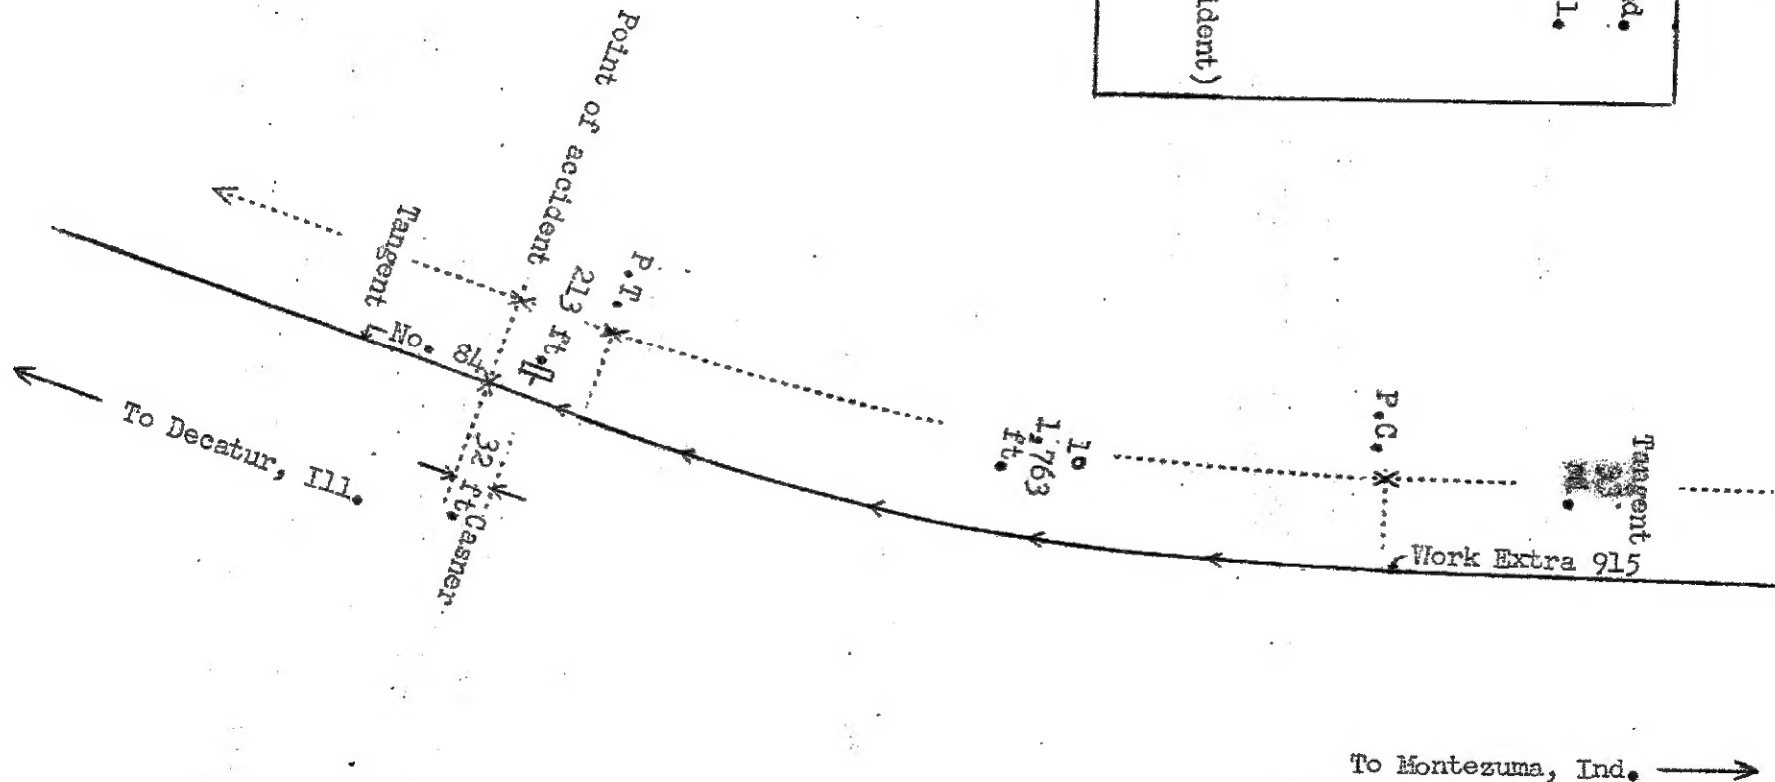
Report No. 3539
 Baltimore and Ohio Railroad
 Casner, Ill.
 October 15, 1953

Montezuma, Ind.
49.7 mi.
T.Y. Tower, Ill.
9.1 mi.
Atwood
3.5 mi.
Pierson
3.4 mi.
Hammond
6.6 mi.
La Place
4.0 mi.
Casner
(Point of accident)
9.1 mi.
Decatur, Ill.

Location of Accident and Method of Operation

No. 84 stopped at Atwood, Pierson, Hammond, and LaPlace, 17.5 miles, 14 miles, 10.6 miles, and 4 miles, respectively, east of Casner. The flagman placed two torpedoes on the rail before the train departed from each of these stations. As No. 84 was approaching the point where the accident occurred, the conductor and the front brakeman were in the caboose at the front of the train, and the flagman was in the caboose at the rear. The two markers on the caboose at the rear were lighted and each displayed a red light to the rear. The flagman had observed the reflection of the headlight of Work Extra 915 at various locations en route, and was aware that Work Extra 915 was following No. 84 closely. He said that after No. 84 departed from LaPlace, he lighted a 5-minute red fusee and placed it on the rear platform of the caboose. When the fusee burned out he lighted three 5-minute red fusees, in succession, and threw them to the track. The first fusee was located approximately 1,500 feet east of the east end of the curve immediately east of Casner. The east end of the curve was 1,976 feet east of the point of accident. He said the second fusee was located a short distance east of the east end of the curve, and the third fusee was located a short distance west of the east end of the curve. Before the train stopped at Casner he alighted from the caboose and proceeded eastward to provide flag protection. His flagging equipment consisted of a white lantern, torpedoes, and 5-minute red fusees. He placed two torpedoes on the rail when he reached a point approximately 360 feet east of the caboose. He said that when he reached a point about 500 feet east of the caboose he observed the headlight of Work Extra 915,
